# case study

## ▶▶▶ improving riparian condition and controlling erosion

**location:** 'Nandawar', south-east of Inglewood  
**project:** riparian fencing and erosion control  
**undertaken:** 2000 – current time

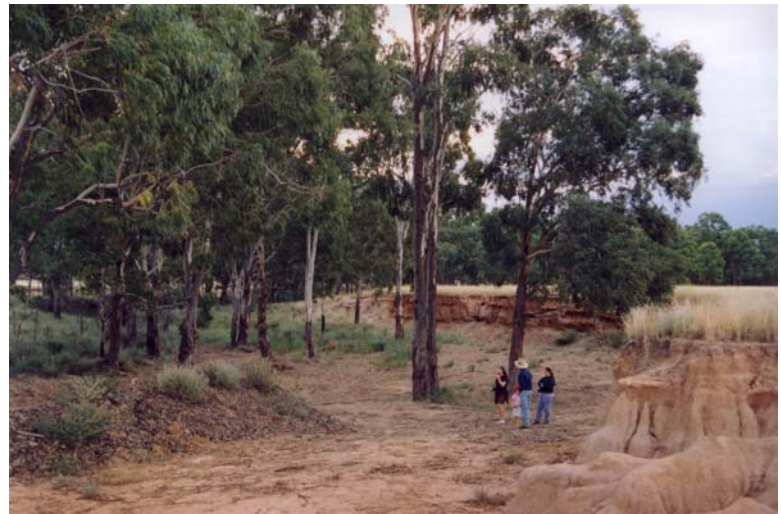
*A rock groyne was placed in the creek to divert flows and minimise erosion.*

As well as fencing the area, a rock groyne was constructed. A groyne is essentially a line of rocks placed at an angle to the bank to divert the flow of water. In this case it was designed to divert the main flow away from a badly eroded section of the creek bank and prevent future flows from eating away at the base of the bank. Staff from the Landcare and Catchment Centre in Goondiwindi and the Department of Natural Resources and Mines assisted in the design of the groyne and other earthworks.
