land case study

▶▶ making spreader banks work for your land

location: 'Gwenbrook', 60 km north-west of Roma, Queensland
project: increase water infiltration and halt erosion with spreader banks
undertaken: 2003 to 2004

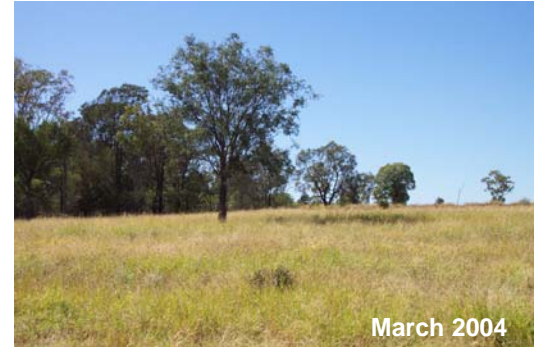
March 2004

Above: After the rains came, the spreader banks showed 'amazing' results on "Gwenbrook".

After the work was completed, a wet summer gave the site a good test. “We have seen spectacular results – the banks have held and there has been a lot of grass growth,” said David Thomas.

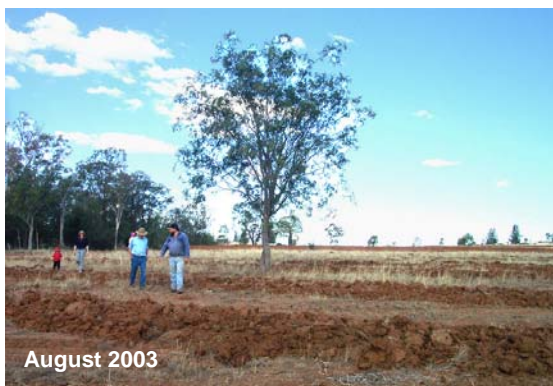
August 2003

Above: these contour banks force water to spill over into stable pastures, instead of down gullies.

After funding was received, Bill Bryant from the Department of Natural Resources and Mines in Roma, surveyed the area to give advice on the most suitable structure to control the water flow. He advised water spreader banks, a type of contour bank where the water spills over to the stable pasture instead of just down the gully. This solution isn't suitable for every situation as there needs to be some stable pasture to spread the water to, otherwise the erosion will continue on the next area of land.

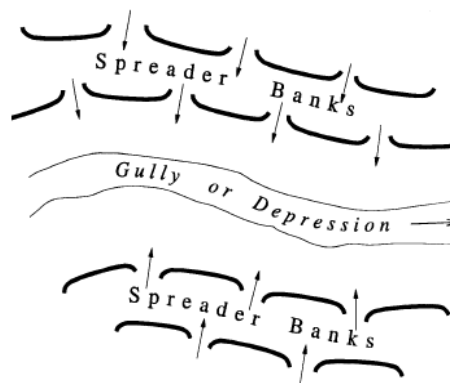
Diagram 1: Water is captured and spread out over the land or passed through to lower land.
Courtesy of DNR Water Facts

Water spreading banks aim for maximum utilisation of runoff by first intercepting it and then disposing it on a broad front to irrigate low rainfall crop or pasture country.¹
