Solar water pump secures reliable water on grazing property

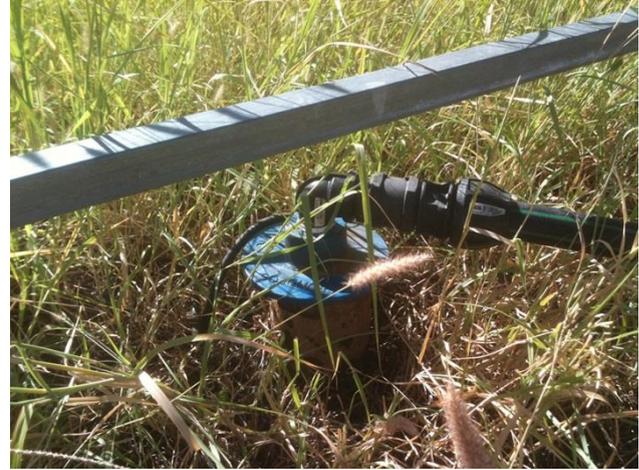
Above: The solar submersible pump in action

A solar submersible pump was installed to replace the windmill network and ensure a more reliable water supply.

- The solar bore pump consists of a submersible pump and 2 x190w panels (0.38kWh).
- Bore depth: 38 metres with standing water at 25 metres and pumping from 35 metres.
- Pump rate: 2,275 litres (500gal)/hr at full capacity.
- Total system costs: \$ 8,277 – (submersible pump \$4,028; solar kit \$4,249).
- Installation costs: \$600.
- Miscellaneous parts (poly pipe, connections): \$1000.

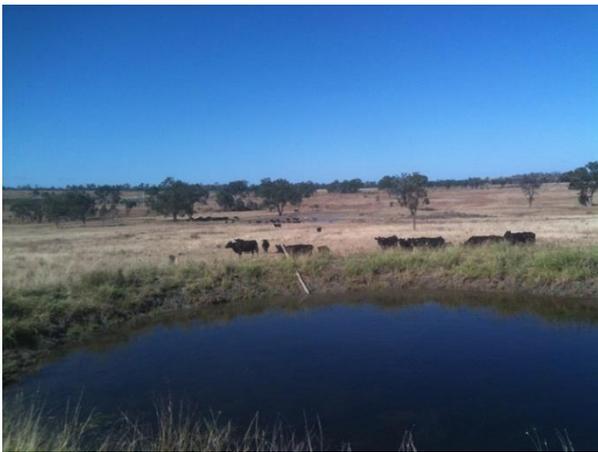
Left: Water is pumped into a turkey's nest

Water is pumped from the bore directly into a turkey's nest (dam) storage facility and gravity-fed into a cattle trough.

The pipeline from the bore can also be disconnected and attached to another pipe to bypass the turkey's nest when it reaches capacity and the water is fed directly into a lower dam 200 metres away.

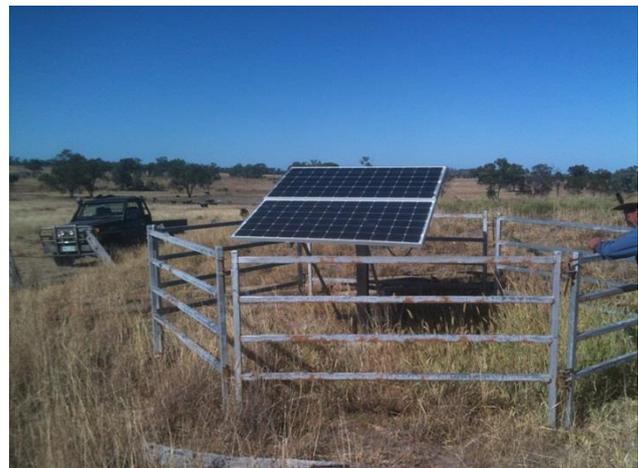
Below: The solar panels that power the pump

The pumping rate varies according to the light level and the amount of dirt on the panels.

On the day of inspection at 10:30am in early May, 2013, there was little cloud cover and the solar panels were generating 0.25 kWh (1500 litres per hour) which was still sufficient to ensure enough water was being pumped to maintain dam levels.

When the panels were cleaned this rate was improved to 0.30kWh (1796 litres).

This shows the importance of regularly cleaning the solar panels to ensure maximum pumping capability is maintained.
